Manhole Inspection Summary

Manhole # S15YY1005MH

Insp Date: **8/22/07 2:27 PM**

Location Address: **2028 GREENBERRY RD**

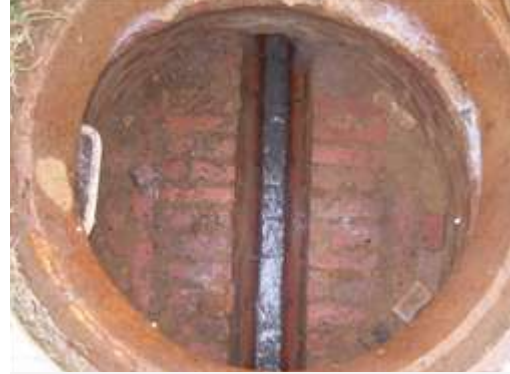
Top View

Frame leaks. Adjustment deterioration and infiltration. Evidence of surcharge - Bench debris.

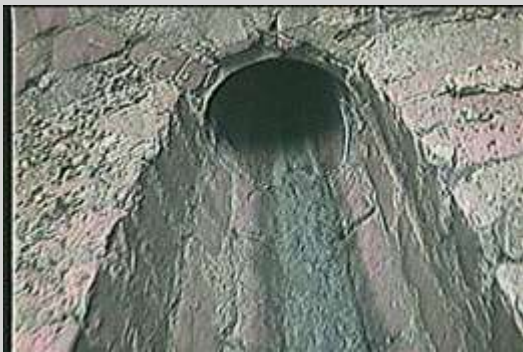
8 in. Circular Gravity Sewer Pipe Out @ 12 O'Clock

Barrel deterioration and infiltration. Channel deterioration.

Infiltration: **Evidence** Pipe Seal Cond: **Cracked**

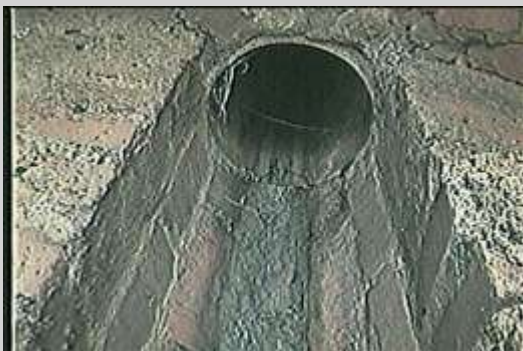
8 in. Circular Gravity Sewer Pipe In @ 6 O'Clock

Infiltration: **None** Pipe Seal Cond: **Roots**
